Watershed Working Group

Santa Rita Creek WS

Santa Rita Creek Upper Subwatershed

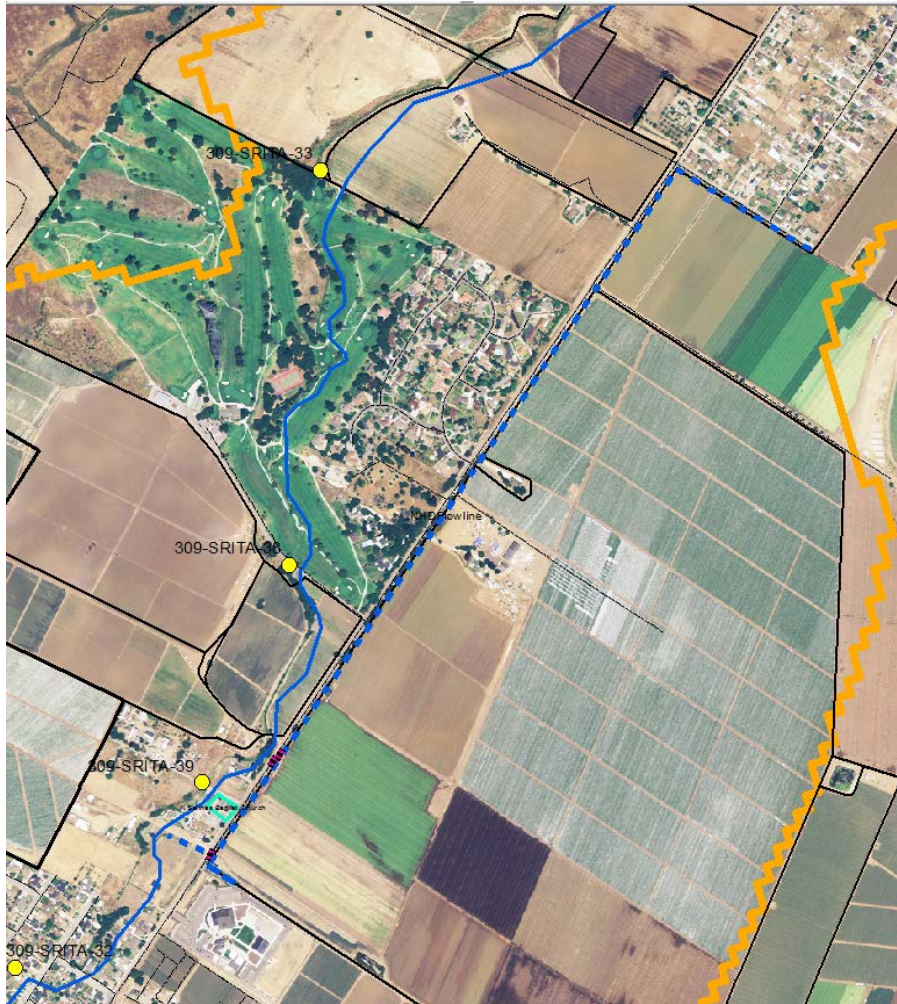
Ditches and Culverts

Ditches can carry water to a different monitoring point that the traditional watershed runoff approach.

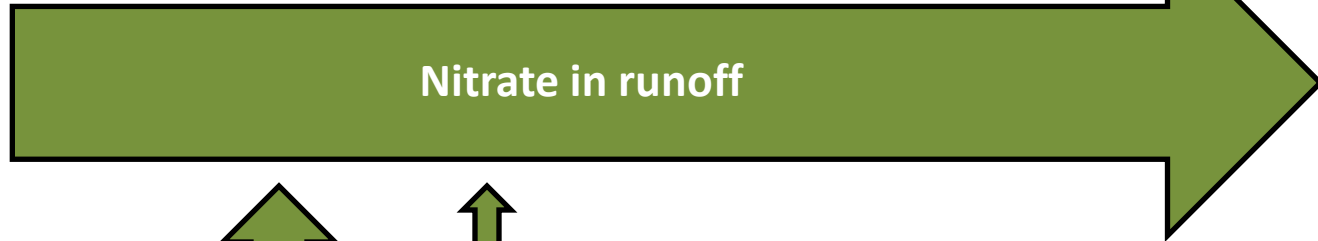
Nitrate from groundwater contamination
in well (0 to >30 mg/L as N)

“Natural Nitrate”
(unimpacted water;
Likely < 2 mg/L as N)

Nitrate in runoff

Fertilizer N added to
irrigation water

Nitrate picked up from field
surface (often < 5 mg/L as N)
